Nevada Gold - Tech Bulletin 13

Nevada Gold Ticket Dispensers with AMZ-PLUS & AMZ1100 bill validators.

INSTALLATION INSTRUCTIONS FOR THE NEW \$ 10 UPGRADE KIT

Stacker models: AMZ-PLUS and AMZ-1100.

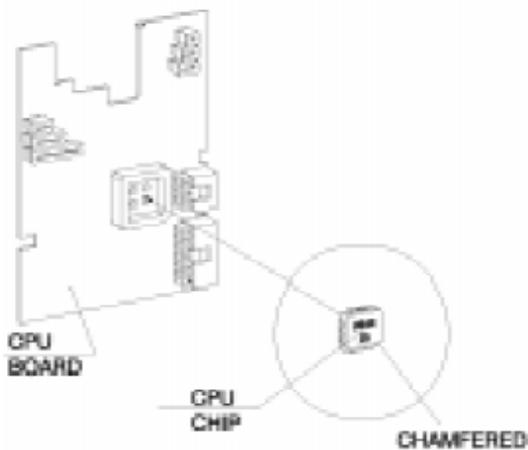
AMZ-154 and AMZ-PLUS models

STEP 3: Locate the CPU chip (AMZ-PLUS model) or the PROM chip (AMZ-1100 models).

IMPORTANT: Note the location of the chamfered edge before you remove the chip.

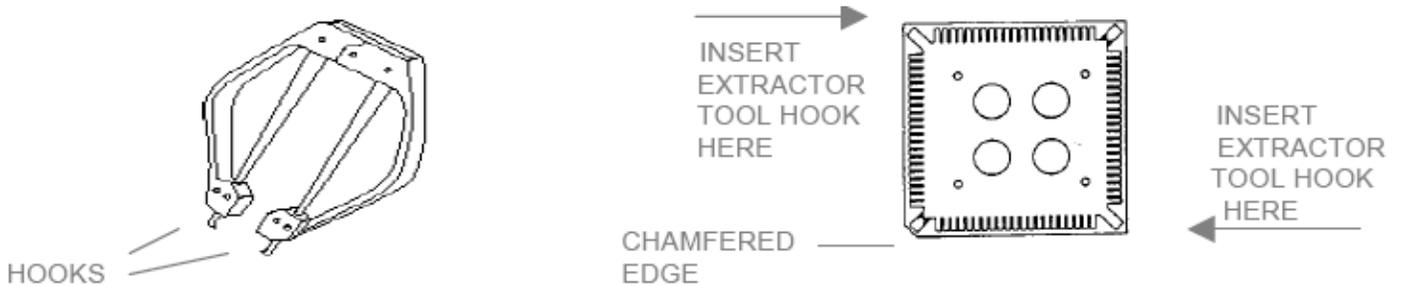
STEP 4: Locate the corner slots in the socket and insert the hooks of the extraction tool. While gently squeezing the tool, the chip can be lifted out of the socket. Pay attention to the fact that one corner of the chip has a chamfered edge. The socket also has a corner to fit this edge.

WARNING: Only use extraction tool to remove chip, using other tools such as screwdriver will damage socket.

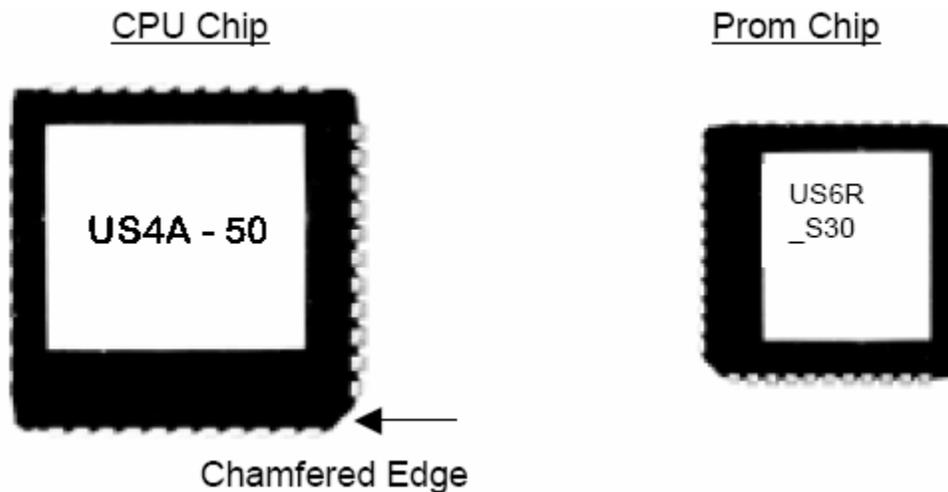
STEP 5: Locate the chamfered edge on the new chip, place the new chip in the socket and press down.

WARNING: The chip should go down into the socket with little effort. DO NOT FORCE IT. DO NOT ALIGN THE CHIP ACCORDING TO THE POSITION OF THE LABEL. MATCH THE CHAMFERED EDGE.
